Certificate of Crash Test according to

ISO 10542-1:2012 Wheelchair tiedown and occupant-restraint systems - SWM & ISO 7176-19 – 2008 Wheeled mobility devices for use as seats in motor vehicles

Assignment:	Crash testing of wheelchair and WTORS according to ISO 7176-19 sections 5.2, 5.2.1 and 5.2.2. as well as ISO 10542 sections 5.2.4 and 5.2.5
Date of testing:	23 May 2022
Test object/Wheelchair:	Medema MC 1144 Spinalus 3 with an adaptation kit for Dahl docking systems, utilising Dahl kit #503236
Mass of wheelchair:	174,5 kg.
Serial no:	not informed
WTORS:	Dahl WTORS that meet requirements set out in ISO 10542 Wheelchair restraint system – Dahl Docking Station Occupant restraint – Dahl 3p. shoulder and lap belt #500984, all items certified by TÜV Rheinland test report no. 175XS0156
Test dummy/ATD:	The test was carried out using a Hybrid II 50% Male dummy with a mass of 77 kg.
Measuring:	The deceleration was measured by accelerometers mounted on the crash test sled.
Photography:	The test was filmed with a high speed camera at 500 fps. Still pictures, pre and post test, was also taken.
Test results:	See page 2

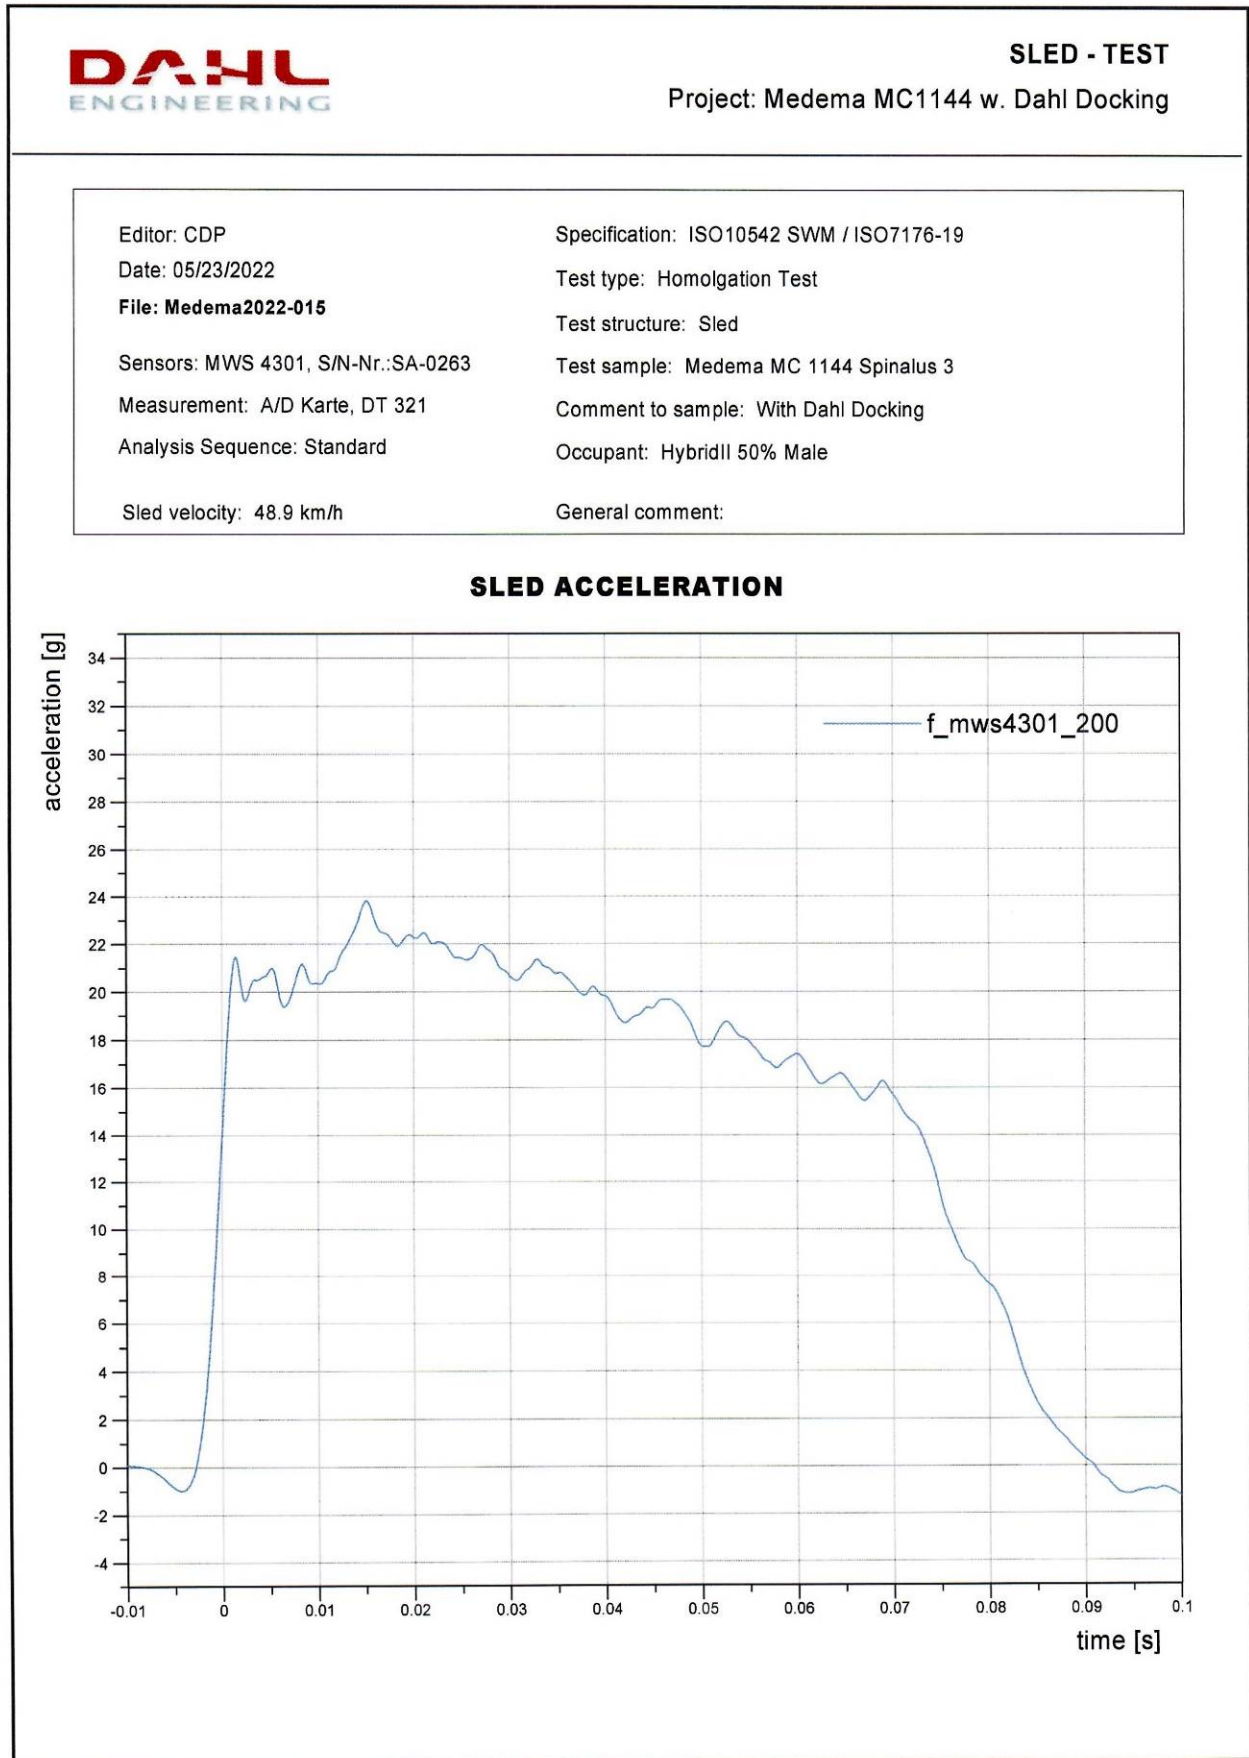
Plotted graph and speed

Sled deceleration and speed:	See page with plotted graph and speed

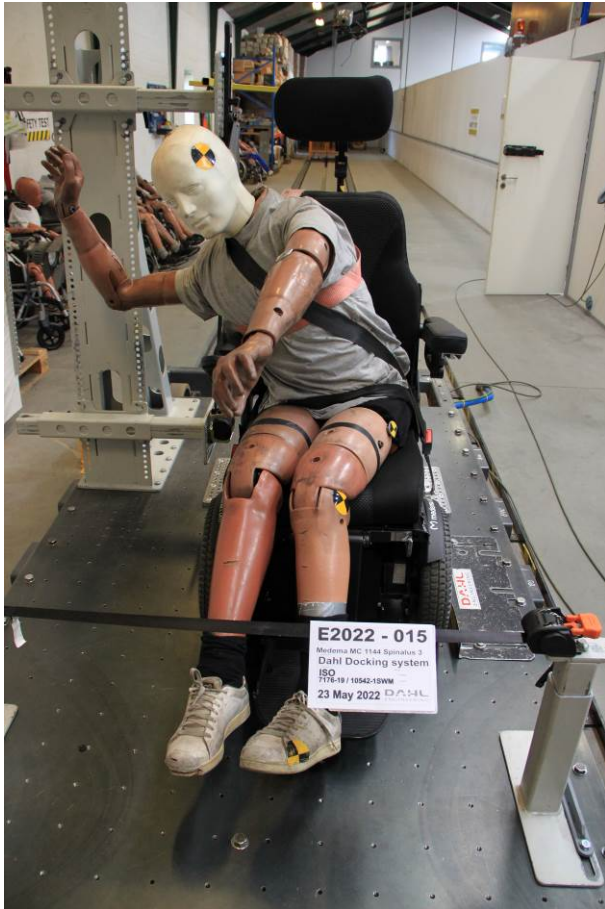
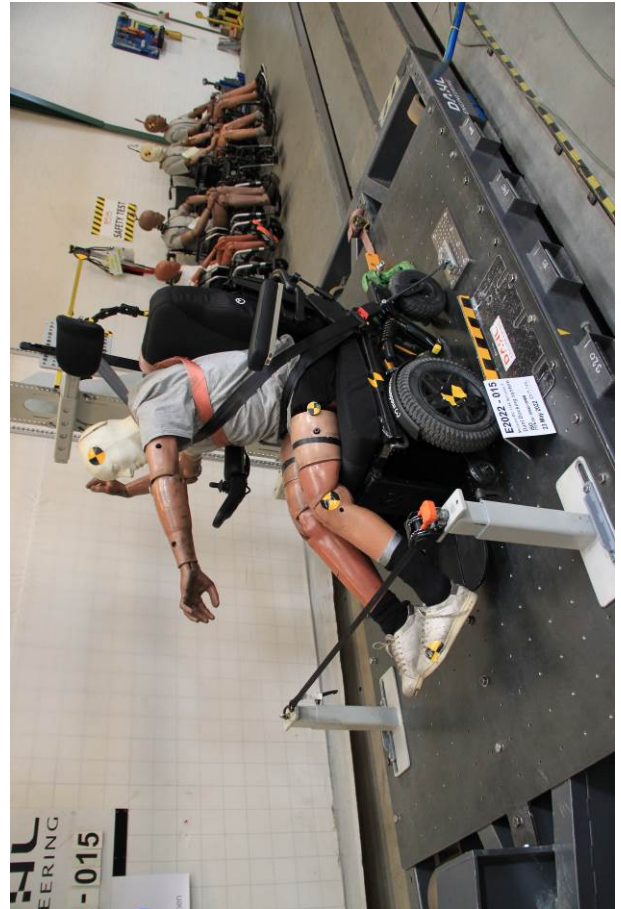
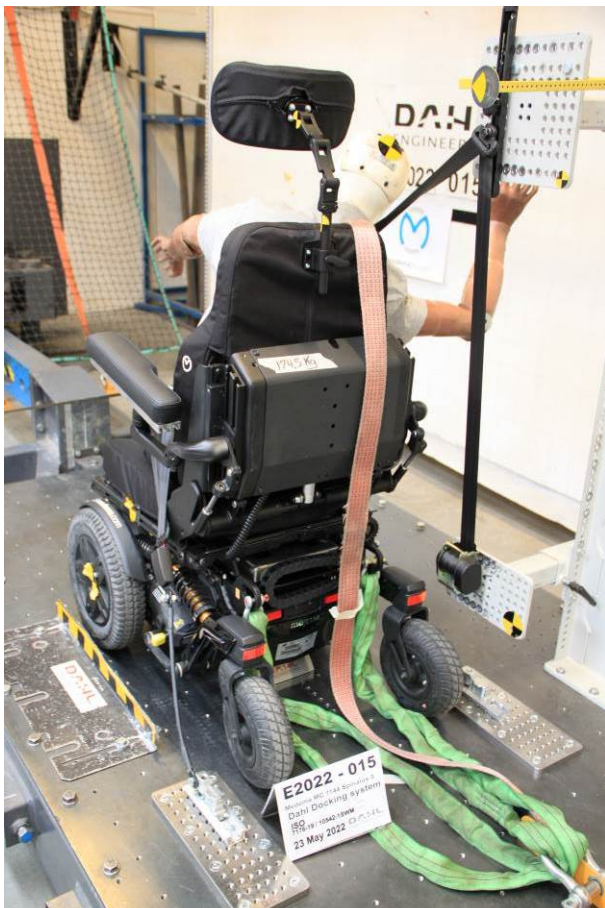
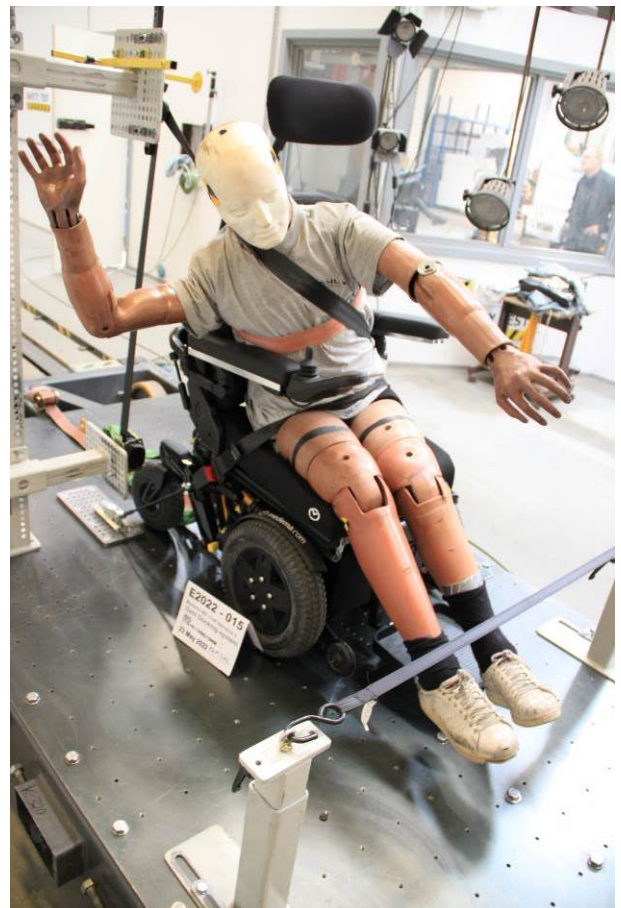
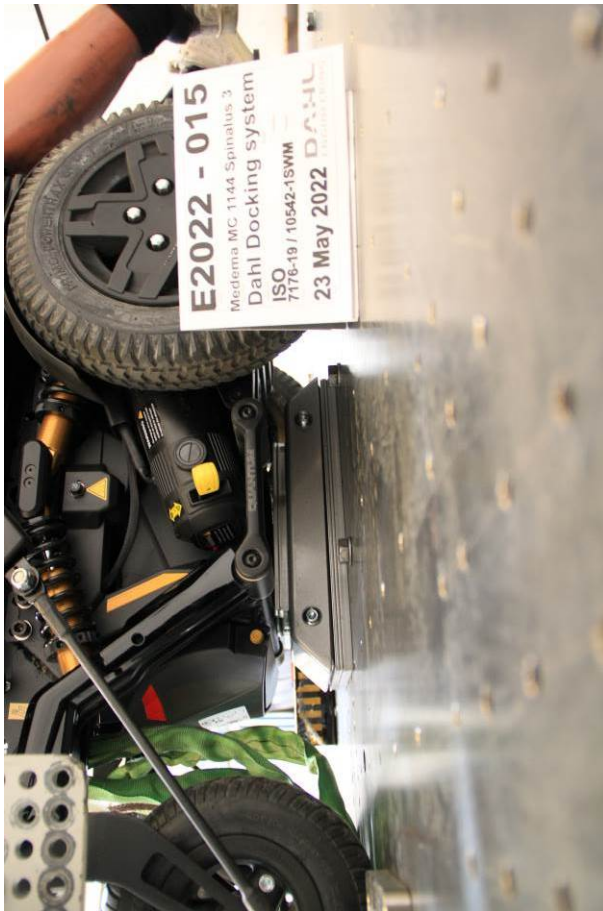
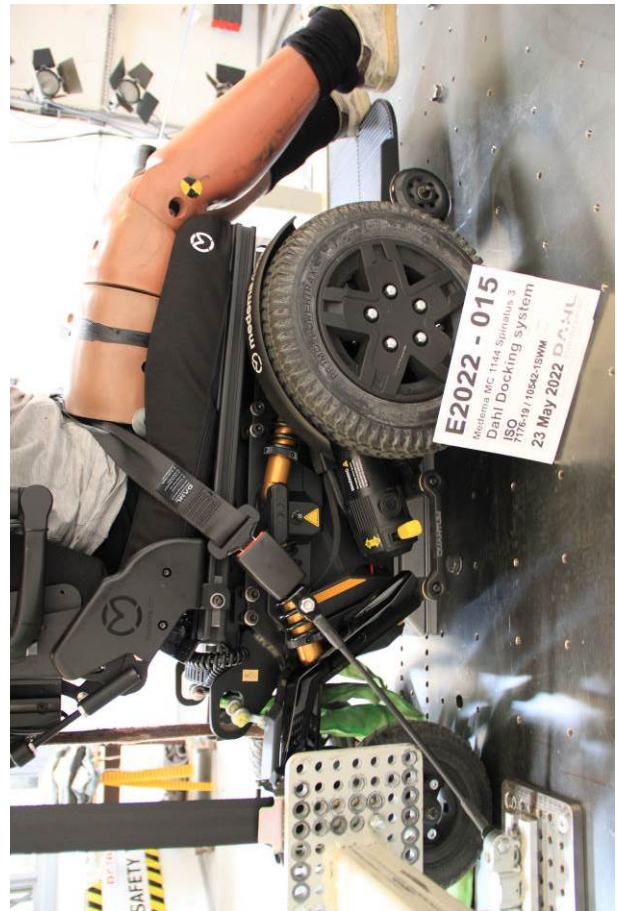
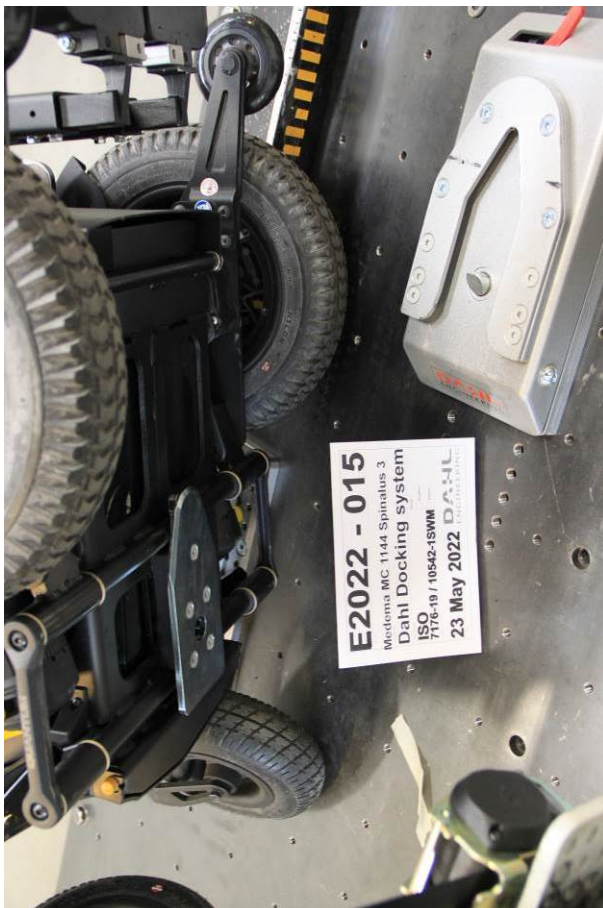
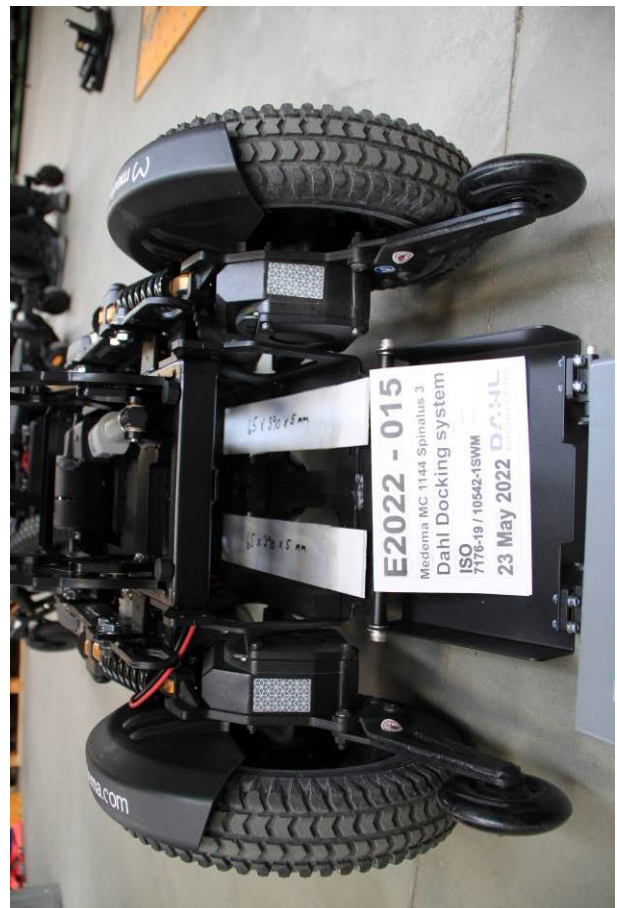
Post test photos

5.2.2	After the test	
	The wheelchair remained in an upright position on the platform	X
	The ADT remained in the wheelchair with its torso at an angle of not more than 45° to the vertical, when viewed from any direction	X
	There were no visible signs of material failure on the wheelchair securing points	X
	There were no components, fragments or accessories of the wheelchair with a mass of more than 100g that completely separated from the wheelchair	X
	There were no fragmented or separated component, that may contact the occupant, produced with sharp edges less than radius 2 mm	X
	There were no visible signs of failure on the wheelchairs primary load carrying components	X
	There were no visible signs of failure on the wheelchairs seat adjusters	X
	The ADT was removed from the wheelchair without the use of tools	X
	The wheelchair was released from the tie-down system without the use of tools	X
	The post test decrease of the mean H-point height is not more than 20%	X
